MEMORANDUM

SUBJECT: Government Creek

DATE: March 2, 1978

On 3-1-78 Mike Haddix, Gerry Downey and Bryan Rahe walked Government Creek (Gravina Island) for the first time. The following minnow trap data was collected:

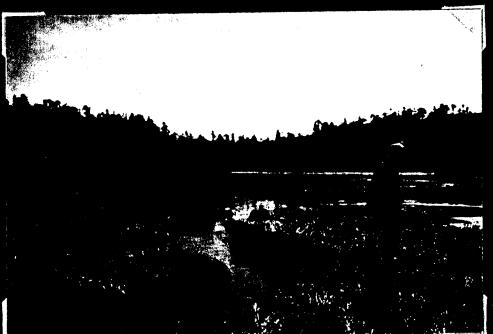
Bryan Rahe standing in slough area near 1st lake on the left fork of Government Creek.

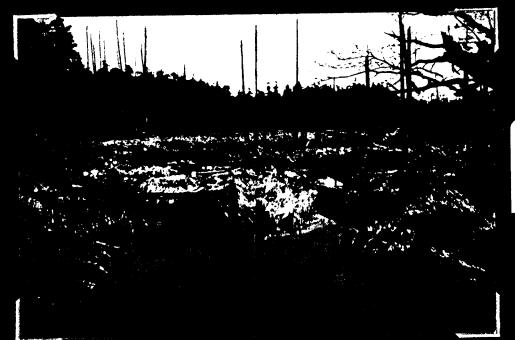
Beaver dam, slough area near lst lake on the left fork of Government Creek.
